Flood Control Project Maintenance
2013 Structure Summary Report
Overall Unit and Item Ratings

Reclamation District No. 2063 Crows Landing

Lateral No. 6 Pumping Plant

Flood Control Project Maintenance**Unit Cover Sheet****2013 Pumping Plant Inspection Results****Reclamation District No. 2063 Crows Landing**

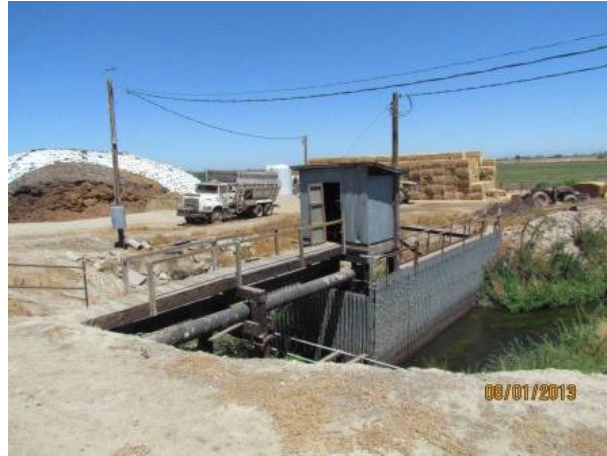
Levee Mile Report Line	4
Start Levee Mile	0.00
End Levee Mile	0.00
Location	
Category	Pump Stations
Item	Plant Building

4	0.00	0.00	Pump Stations	Plant Building		A	Item inspected visually only. Item was not operated during the inspection. Inspector Comments: The plant building appeared to be in a good structural condition.	37.431070 ° -121.011730 °	37.431070 ° -121.011730 °	4 Y	
5	0.00	0.00	Pump Stations	Cranes		N	Inspector Comments: Crane doesn't exist at this location.	37.431070 ° -121.011730 °	37.431070 ° -121.011730 °	5	
6	0.00	0.00	Pump Stations	Safety		A	Item inspected visually only. Item was not operated during the inspection. Inspector Comments: There was no any significant safety hazard present outside of the pumping plant during inspection and the handrails prevented failing hazards around the pumping plant.	37.431070 ° -121.011730 °	37.431070 ° -121.011730 °	6 Y	
7	0.00	0.00	Pump Stations	Pumps		A	Inspector Comments: Pumps were fully operation and they were tuned on during the inspection.	37.431070 ° -121.011730 °	37.431070 ° -121.011730 °	7 Y

View of the pumping plant.

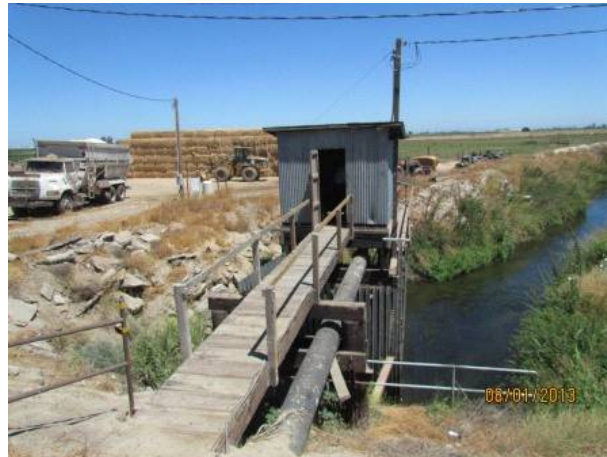
Levee Mile Report Line	6
Start Levee Mile	0.00
End Levee Mile	0.00
Location	
Category	Pump Stations
Item	Safety

View of the handrails.

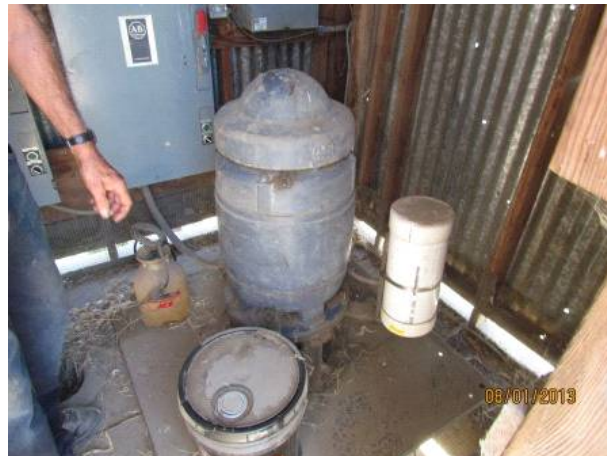
Levee Mile Report Line	7
Start Levee Mile	0.00
End Levee Mile	0.00
Location	
Category	Pump Stations
Item	Pumps

View of one of the pumps inside the pumping plant.

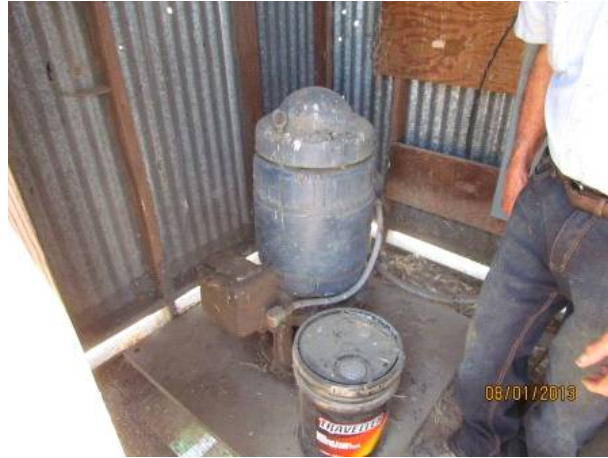
Levee Mile Report Line	7
Start Levee Mile	0.00
End Levee Mile	0.00
Location	
Category	Pump Stations
Item	Pumps

View of another pump inside the pumping plant.

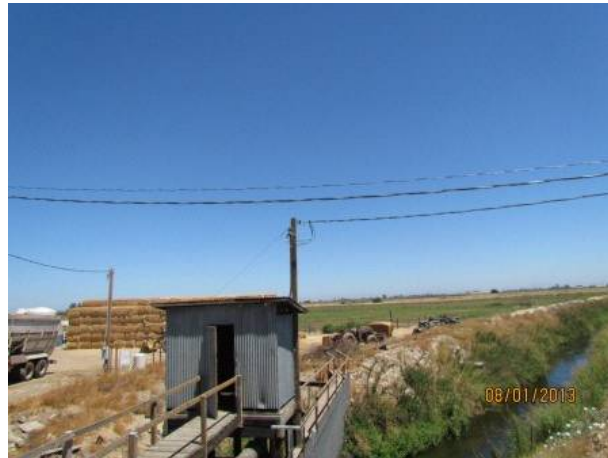
Levee Mile Report Line	9
Start Levee Mile	0.00
End Levee Mile	0.00
Location	
Category	Pump Stations
Item	Power

View of the power sources for the pumping plant.

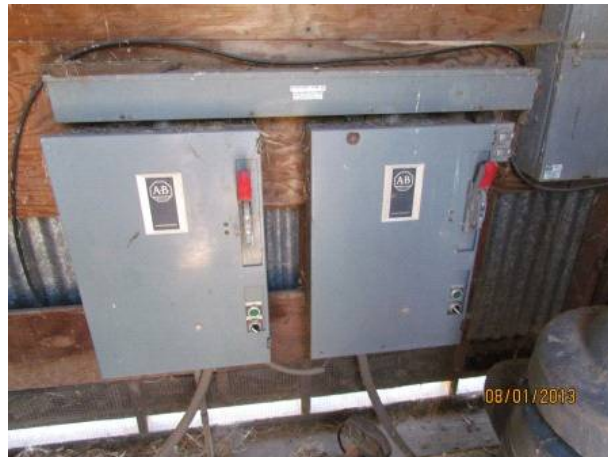
Levee Mile Report Line	10
Start Levee Mile	0.00
End Levee Mile	0.00
Location	
Category	Pump Stations
Item	Pump Control Systems

View of the power control systems.

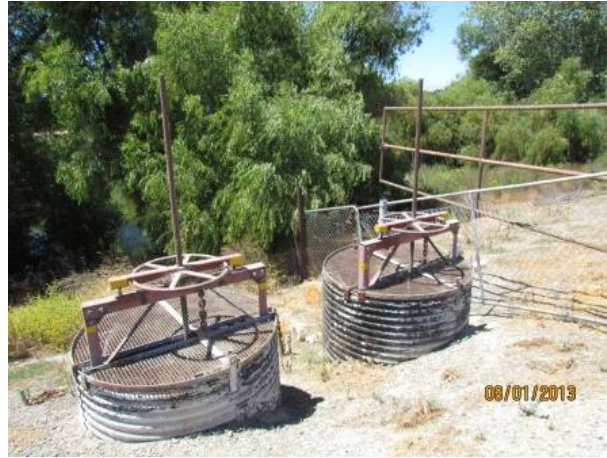
Levee Mile Report Line	11
Start Levee Mile	0.00
End Levee Mile	0.00
Location	
Category	Pump Stations
Item	Sluice / Slide Gates

View of the slide gates at the pumping plant.

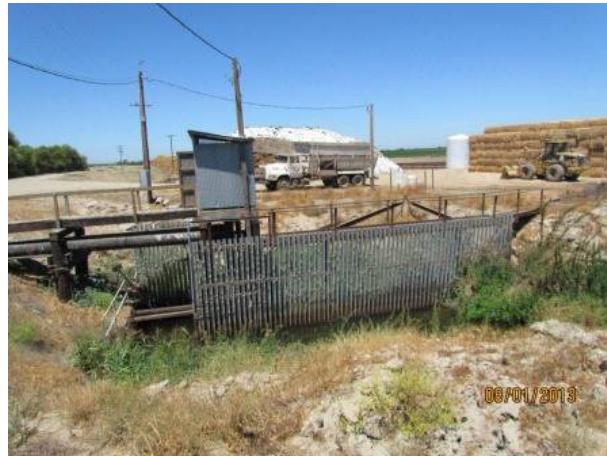
Levee Mile Report Line	13
Start Levee Mile	0.00
End Levee Mile	0.00
Location	
Category	Pump Stations
Item	Trash Racks

View of the trash rack.

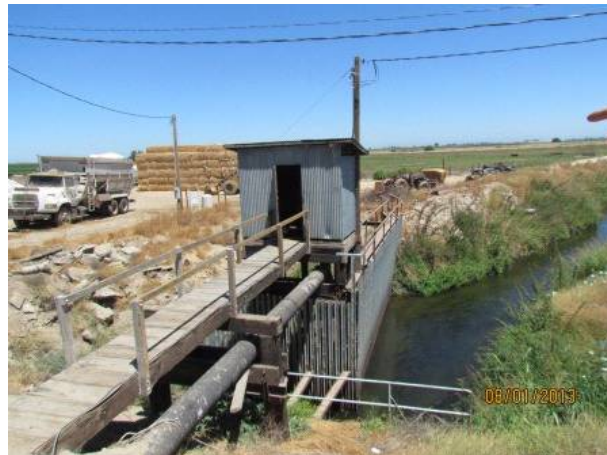
Levee Mile Report Line	20
Start Levee Mile	0.00
End Levee Mile	0.00
Location	
Category	Pump Stations
Item	Intake and Discharge Pipes

20	0.00	0.00	Pump Stations	Intake and Discharge Pipes		A	Inspector Comments: The intake and discharge pipes appeared to be in good condition.	37.431070 ° -121.011730 °	37.431070 ° -121.011730 °	20 Y
21	0.00	0.00	Pump Stations	Communications		A	Item inspected visually only. Item was not operated during the inspection. Inspector Comments: Plant operator has cellular phone for communication.	37.431070 ° -121.011730 °	37.431070 ° -121.011730 °	22

View of the pipes at the plant.
